Ohio Department of Transportation

Fracture Critical Member and Fatigue Prone Connection Identification Plan

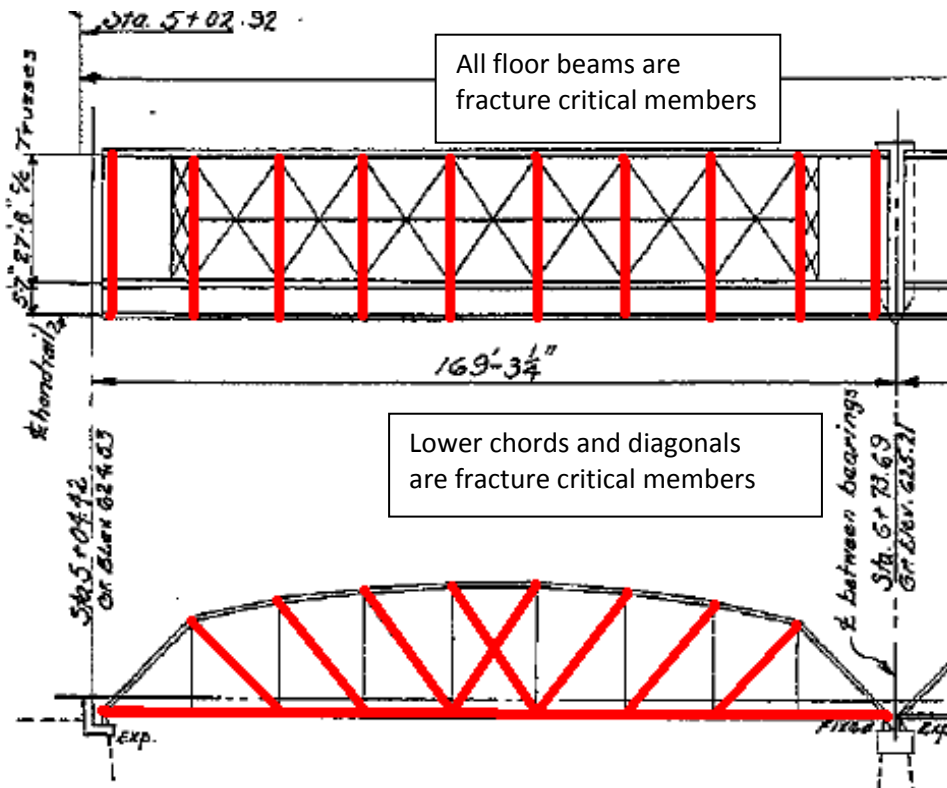
Figure 3 – Highlighted red Floorbeams, Lowerchords and Diagonal tension members are fracture critical, symmetrical all spans

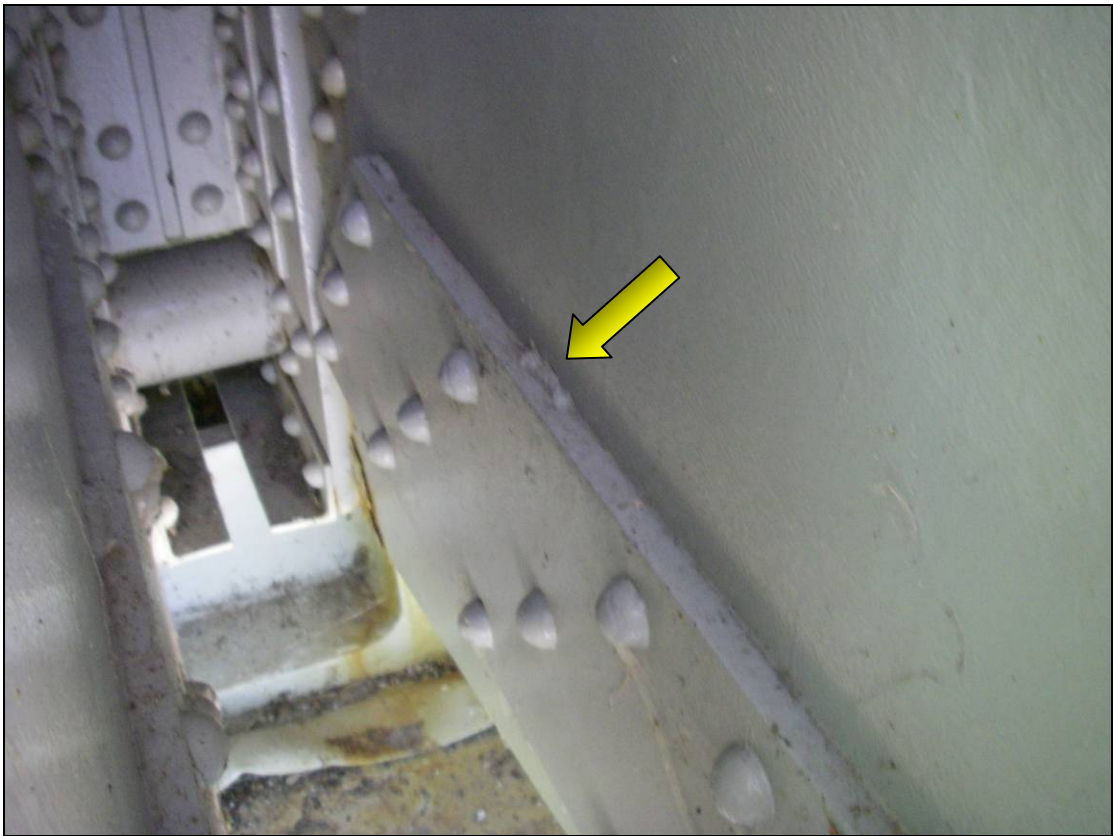
Figure 4a - Tack weld connection at Gusset Plate to Lower Chord flange plates

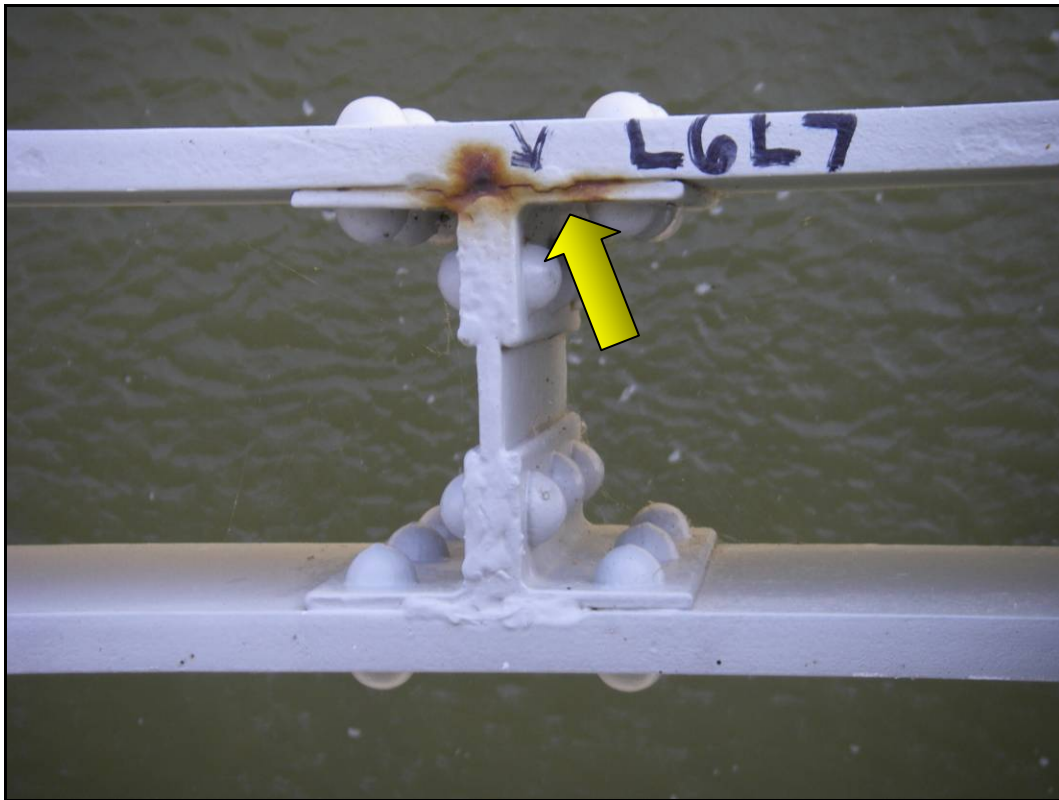
Figure 8b - Tack welds on web-plate diaphragms between lower chord flange plates. Location: Right truss span 4, L6L7, note crack around angle-fusion zone of tack weld

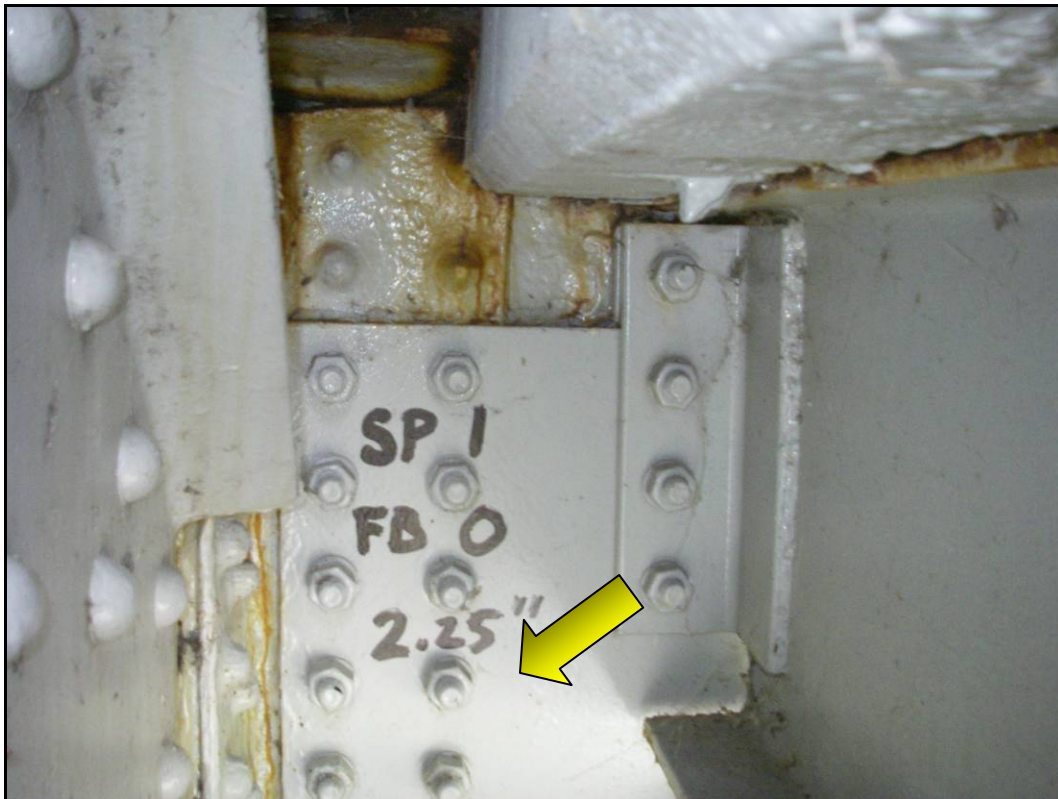
Figure 9 – Retrofit at floorbeam ends over fatigue cracks in floorbeam cope (FB 0 in Spans 1,2,3)

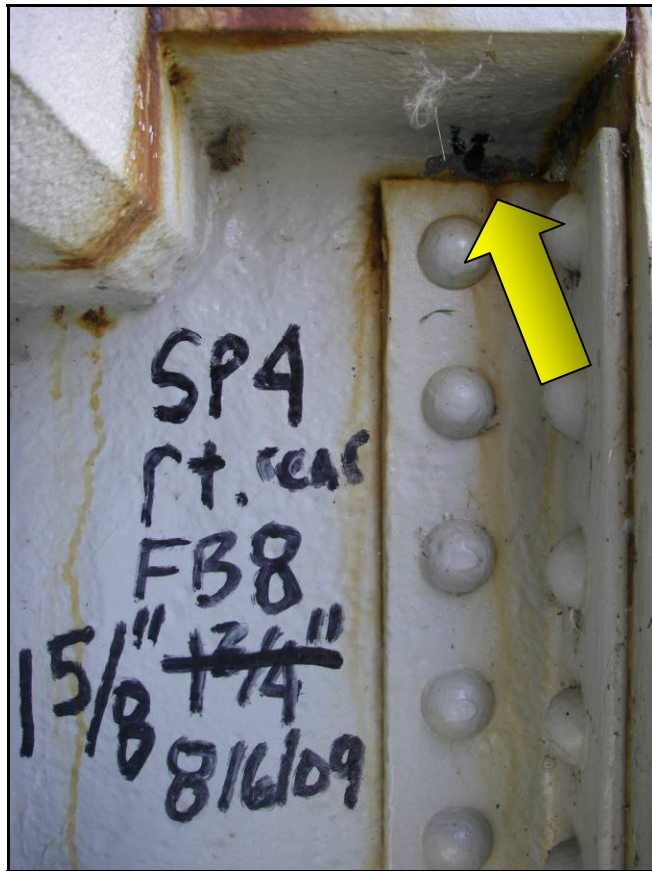
Figure 10a– Fatigue crack in floorbeam web above clip angle to inboard lower chord truss. 1-5/8" long on 8/6/09

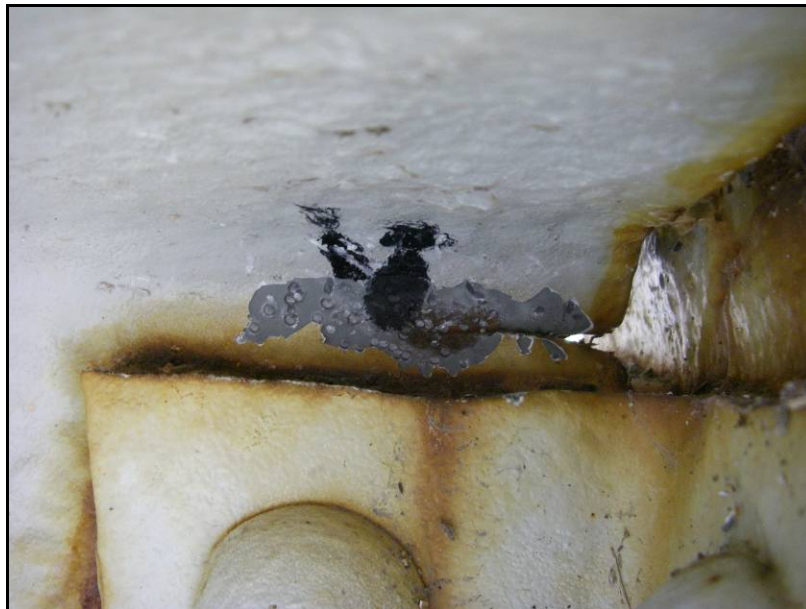
Figure 10b – Fatigue crack in floorbeam web above clip angle to inboard lower chord truss. 1-5/8" long on 8/6/09
